Roof Truss Heel Joints

**ROOF TRUSS HEEL JOINTS**

**RALPH ALFRED PILLINGER**

**ARCHITECTURAL ENGINEERING**

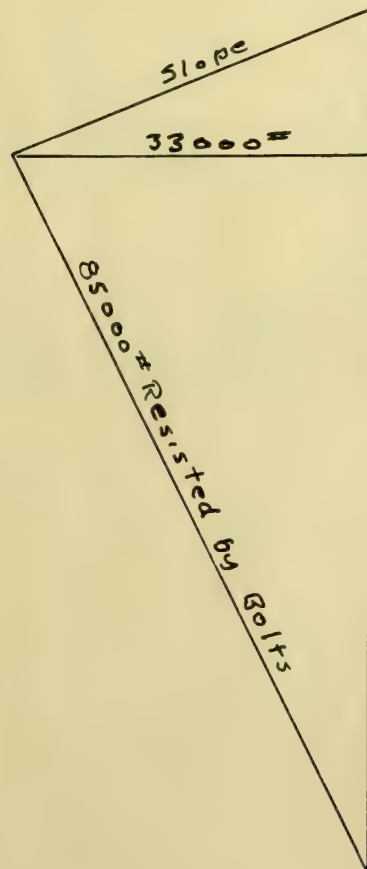
## Design of Joint-No.3.

Joint-13- similar to Joint-No-2-except bolts-run-thru-timber-instead-of-outside them.

Joint has  $8-1\frac{1}{4}"$  Bolts; 1 steel & 1 CI Plate
